Evaluation of in-pavement Flashing Lights on a Six-lane Arterial Pedestrian Crossing

Panos D. Prevedouros, Ph.D.

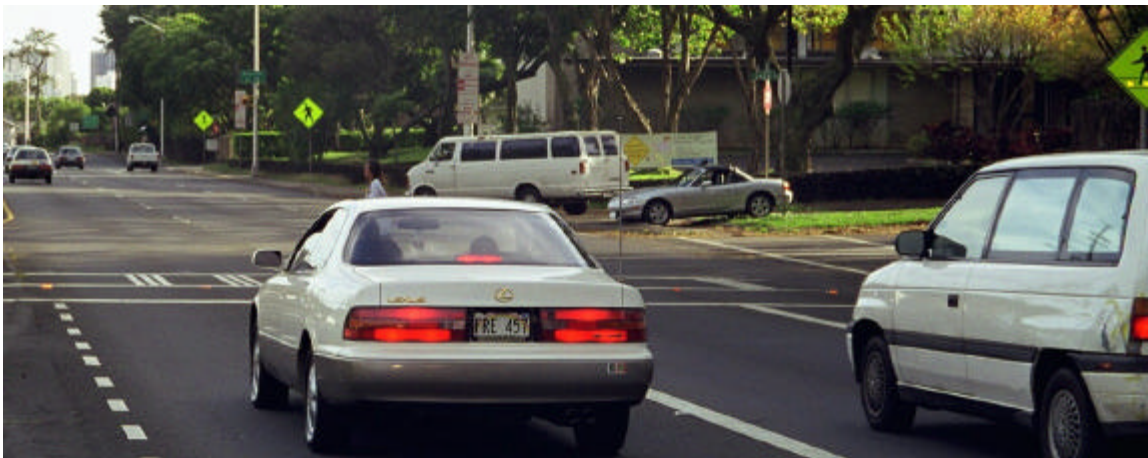
FIGURE 1. Cars stopping for pedestrian crossing while in-pavement lights are flashing.

On March 6, 2000, the Hawaii Department of Transportation (HDOT) activated in-pavement traffic lights system consisting of 24 lights evenly distributed along the edge of the cross walk. Additional elements of the installation included a solar array, batteries, three poles with light-activating push buttons (one at each curb and one on the median) and two custom pedestrian crossing signs containing blinking lights as shown at the right edge of Figure 1.

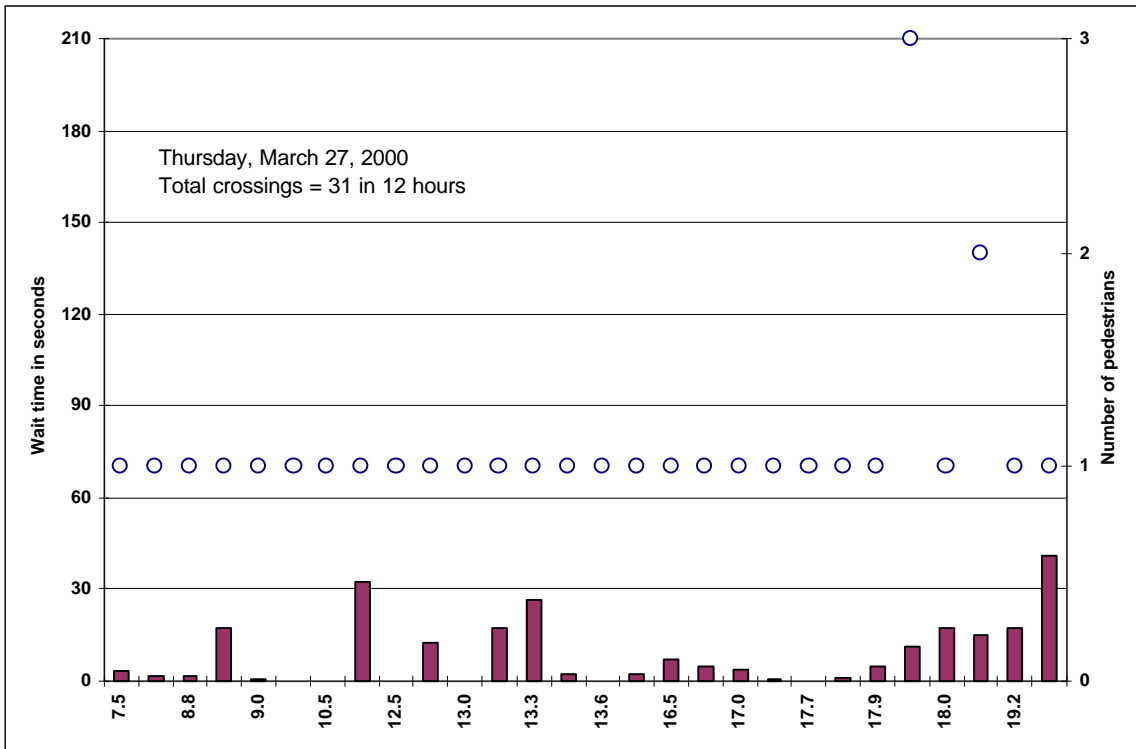
FIGURE 3. Pedestrian crossings and delays with flashing in-pavement lights.

The wait time was measured from the moment that the pedestrian was practically still until the time when he or she stepped onto the travel lane. When two or more pedestrians arrived at the curb, the wait time of the first arrival (which was the longest) was measured. Crossing time was measured with a second stop-watch which was started at the same time when the first stop-watch was stopped. When two or more pedestrians crossed, the crossing time covered the duration from the first pedestrian starting to cross to the last pedestrian completing the crossing.

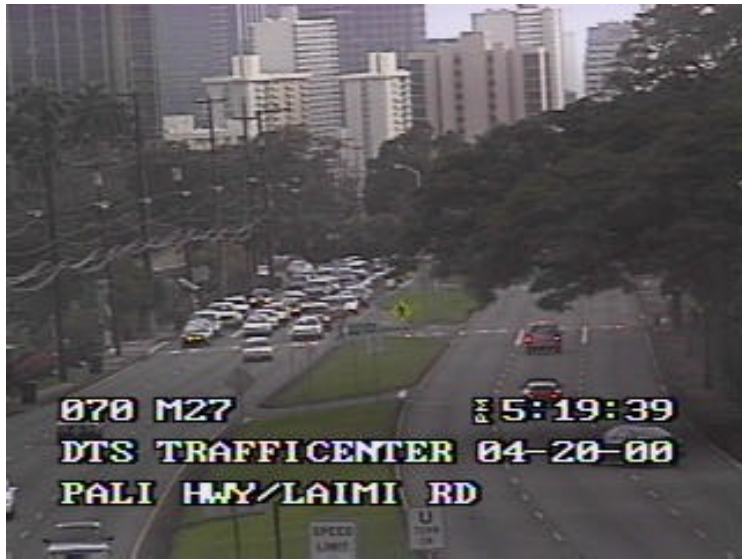
FIGURE 4. Although the in-pavement lights cannot be seen due to distance and CCTV camera location, it is obvious that they caused a large NB platoon to stop for a pedestrian. The pedestrian is about 3 ft. to the right of the stopped car in the fast lane. Also, the brake lights of SB vehicles are on.

The evaluation showed that this experimental application of in-pavement flashing lights produced clearly positive results and the experiment can be characterized as a success (Figures 4 and 5). The processing of pedestrians in terms of efficiency (lower delays) and safety (many more vehicles stopped or slowed down) improved considerably and several of the tested differences were statistically significant. The results may be summarized as follows:

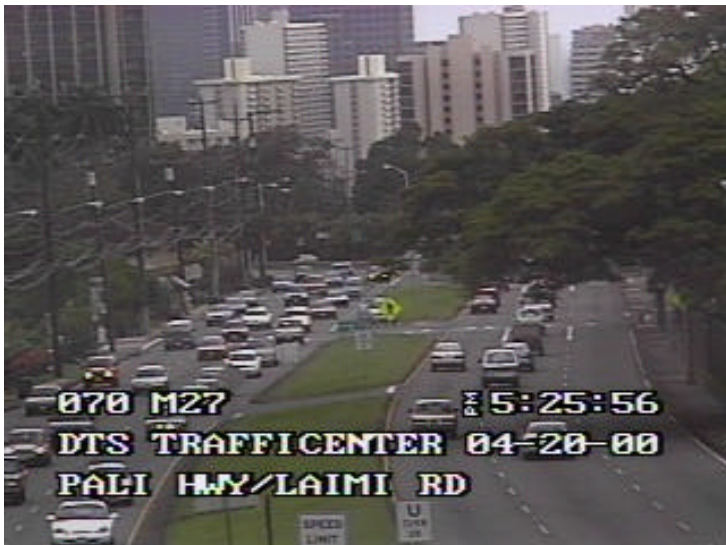
FIGURE 5. An image capture about 6 minutes later shows a typical view of traffic flow by the subject pedestrian crossing.
