# CROSSWALK ENHANCEMENT COMPARISON STUDY

May 7, 2001

Prepared by the  
Department of Transportation  
(408) 277-4304

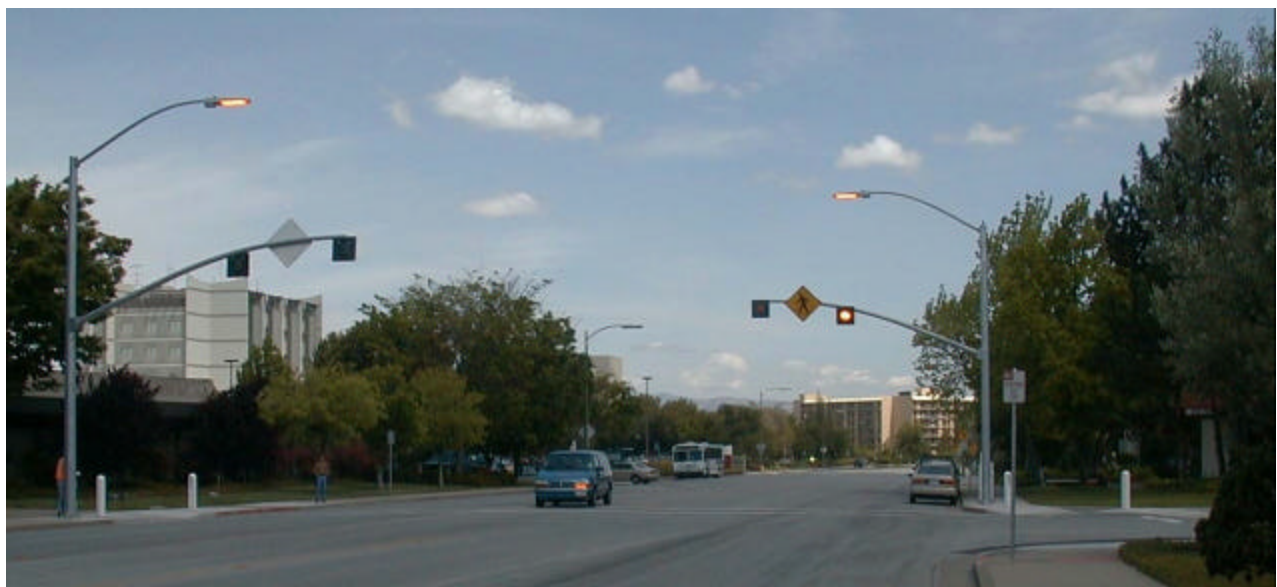
Figure 2: Samaritan Drive and Kinghurst Way standard overhead yellow flashing beacon

The standard overhead yellow flashing beacon system consists of a Caltrans standard mastarm with two 12-inch yellow flashing beacon heads per direction and one W-54 sign placed in between the two heads. This system also activates when a pedestrian passes through a set of bollards that has an optical beam running between them.

The installation included a 25-foot luminaire signal mastarm with two 12-inch yellow flashing beacon heads per direction. W-54 (pedestrian crossing symbol with crosswalk lines) signs were installed on the mast arm between the two flashing beacon heads. There were also W-54A (advance pedestrian crossing symbol) signs in advance of the crosswalk for both approaches.

The City of San Jose selected two intersections with existing, uncontrolled crosswalks to conduct the study (see Figure 1). The intersection of Samaritan Drive and Kinghurst Way was selected for the standard overhead yellow flashing beacon (see Figure 2). The intersection of McAbee Road and Golden Oak Way was selected for the experimental embedded pavement flashing light system (see Figure 3).

Samaritan Drive is a major collector street running in an east-west direction. It is 70 feet wide curb to curb in an 84-foot wide right-of-way and carries approximately 10,000 vehicles per day. The roadway is striped for four lanes and a two way left turn lane with no on-street parking and a continuous sidewalk on both sides of the street. The speed limit on Samaritan Drive is 30 mph and the 85<sup>th</sup> percentile speed is 34 mph. Kinghurst Way is a residential street teeing into Samaritan Drive from the south with a curb to curb width of 36 feet in a 60-foot wide right-of-way. The posted speed on Kinghurst Way is 25 mph. The intersection of Kinghurst Way and Samaritan Drive is controlled with a one-way Stop at Kinghurst Way. The standard overhead yellow flashing beacon was installed at the existing crosswalk on the east leg crossing Samaritan

Drive (see Figure 2). Good Samaritan Hospital is located on the north side of Samaritan Drive in the vicinity of the crosswalk. The crosswalk connects the hospital to the residential and medical facilities to the south, and also serves nearby senior living facilities.

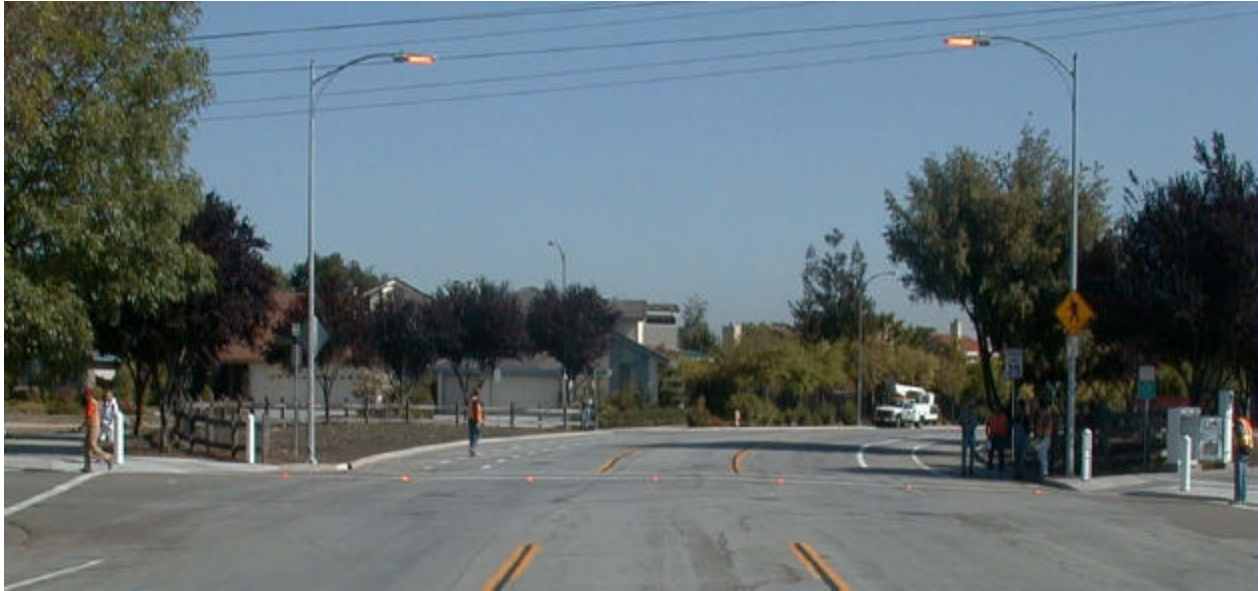
Figure 3: McAbee Road and Golden Oak Way embedded pavement flashing light system

The experimental embedded pavement light system utilizes a series of light emitting diodes (LEDs) in a housing embedded in the roadway which flashes to warn approaching motorists that a pedestrian is entering or is in the crosswalk. The lights shine out towards the oncoming traffic to warn drivers and flash for a set period of time before automatically turning off. The system activates when a pedestrian breaks an optical beam by passing through a set of bollards.

The installation included a total of seven LED embedded fixtures on each side of the crosswalk. A pair of activation bollards and a controller cabinet were installed per the plan. There were W-54A signs installed in advance of the crosswalk for both approaches and W-54 signs were installed at the crosswalk.

McAbee Road is a major collector street running in a north-south direction. McAbee Road is 65 feet wide curb-to-curb in a 90-foot wide right-of-way and carries approximately 6,000 vehicles per day. The roadway is striped for two lanes and bike lanes, with a two way left turn lane. Parking is removed in the vicinity of the crosswalk. The speed limit on McAbee Road is 35 mph and the 85<sup>th</sup> percentile speed is 42 mph. Golden Oak Way is a 36-foot wide curb to curb residential street in a 60-foot wide right-of-way. The posted speed on Golden Oak Way is 25 mph. The intersection of Golden Oak Way and McAbee Road is controlled by a two-way Stop at Golden Oak Way. The embedded pavement flashing light system was installed at the existing crosswalk on the north leg of the intersection. The crosswalk connects a recreational trail through a linear park. A continuous sidewalk exists on both sides of McAbee Road, south of Golden Oak Way. North of Golden Oak Way, on both sides of McAbee Road, there is a

meandering pathway through the linear park. Golden Oak Way has continuous sidewalk on the south side and the north side is connected by a meandering pathway along the linear park (see Figure 3).

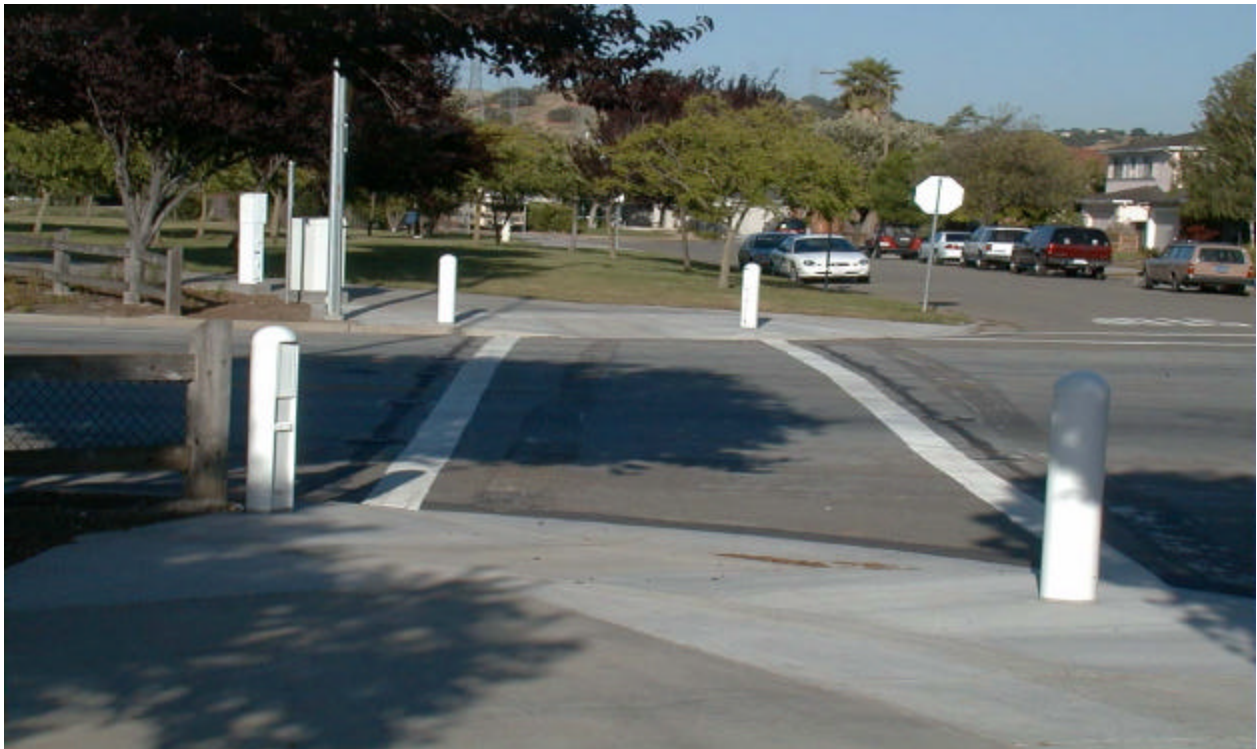
Figure 4: Bollard activation system

A pair of activation bollards were installed on each side of the crosswalk at both locations (see Figure 4). Each bollard contains sensor circuitry and were placed so pedestrians entering a crosswalk must pass between them, automatically activating the built in system. The build-in sensors detect pedestrians using the crosswalk and detect their direction of travel. The build-in sensor module projects infrared beams of modulated light to the respective receiver module. Each module incorporates a high gain detector, allowing the system to activate for crosswalk entry and not for exit.

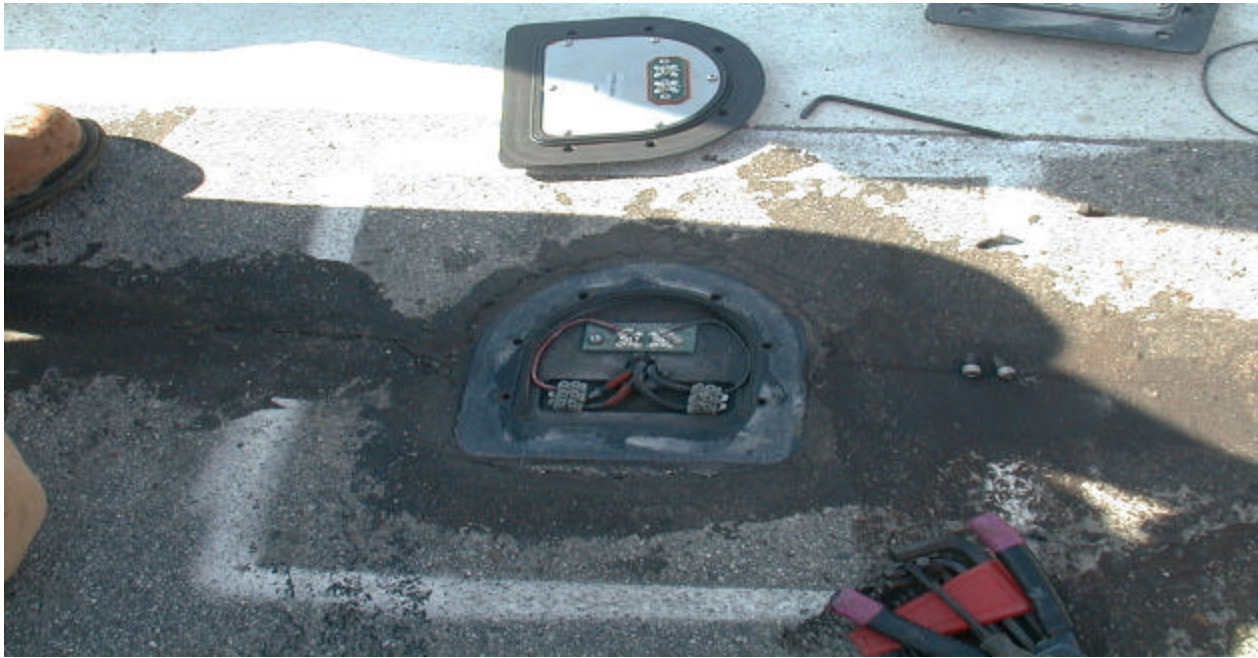
Figure 6: Embedded pavement flashing light system housing fixture

- Prior to final inspection, one of the 14 embedded fixtures developed condensation inside the lens and had a burned-out bulb. The manufacturer replaced the bulb and gasket for the housing fixture (see Figure 6). Two of the fixtures closest to the curb have distinct indentations in the top of the housing, which may have been caused by street sweeping. These two fixtures are still fully functional.

There were some maintenance issues with the experimental embedded pavement lights and the bollard activation system during the six-month test period. These issues included moisture penetration in the fixture housing, vandalism and a malfunction of the bollard detection system. The manufacturer was notified and corrective actions were taken. The experimental embedded pavement flashers appear to be prone to more maintenance needs, particularly at the time of pavement resurfacing and other maintenance activities.

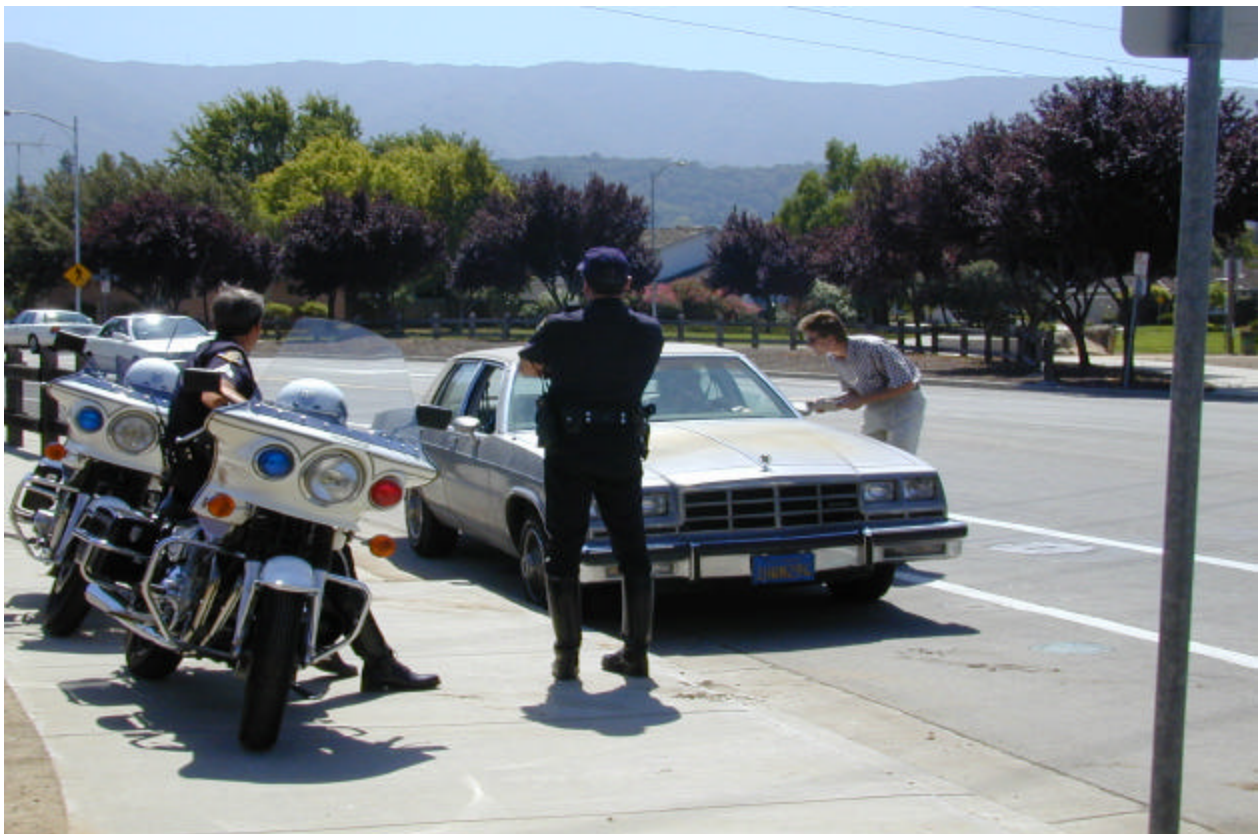
Figure 7: Driver survey

Six months after the installation of the devices, randomly selected drivers were interviewed after passing through the activated crosswalk warning systems. Drivers were flagged to the side of the road by City of San Jose police officers (see Figure 7), and the following questions were asked of the drivers:

- Did you notice the crosswalk in which you passed in the last block?
- Did you notice any pedestrians in or near that crosswalk?
- Did you notice the flashing lights at the crosswalk?
- Are the warning devices effective?

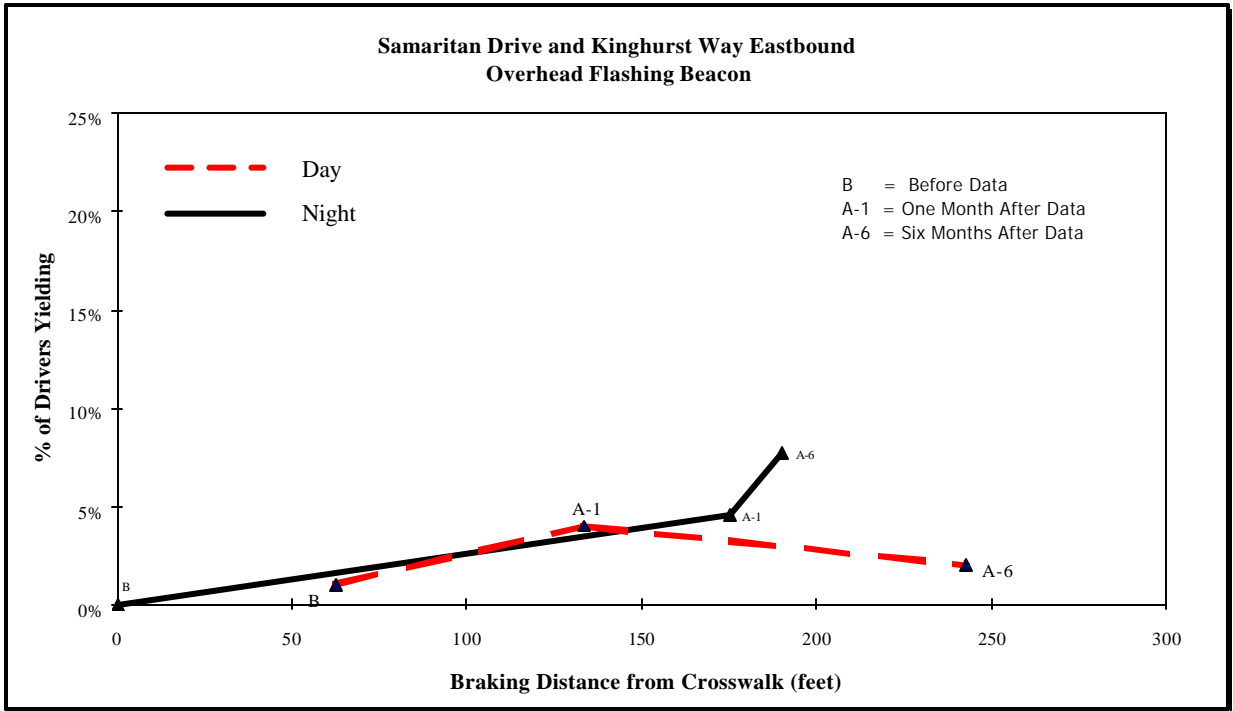
Graph 1: Samaritan Drive and Kinghurst Way eastbound

- Drivers yielding for pedestrians during the day increased from 1% in the before condition to 4% and 2% for one month and six months after installation, respectively. Braking distance during the day increased from 63 feet in the before condition to 133 feet and 243 feet for one month and six months after installation, respectively.
- Drivers yielding for pedestrians during the dark hours of the night increased from 0% in the before condition to 5% and 8% for one month and six months after installation, respectively. Braking distance during the night increased from none in the before condition to 175 feet and 190 feet for one month and six months after installation, respectively (see Graph 1).

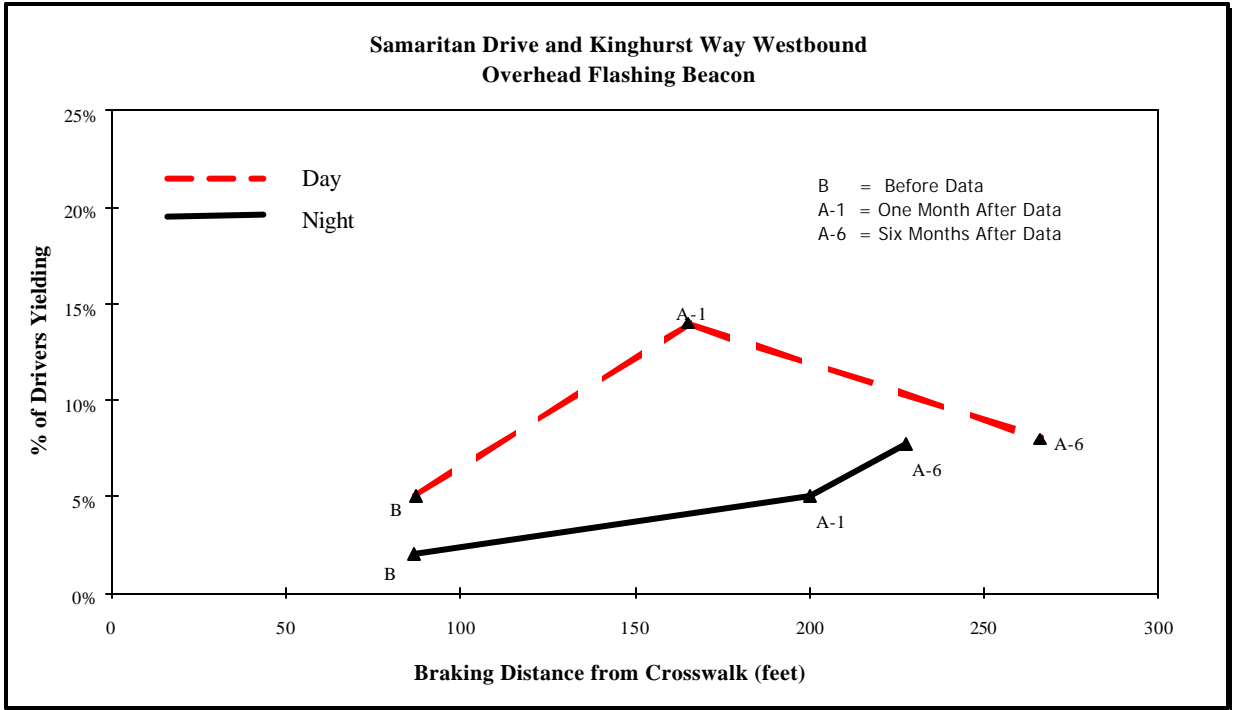
Graph 2: Samaritan Drive and Kinghurst Way westbound

- Drivers yielding for pedestrians during the day increased from 5% in the before condition to 14% and 8% for one month and six months after installation, respectively. Braking distance during the day increased from 87 feet in the before condition to 165 feet and 266 feet for one month and six months after installation, respectively.
- Drivers yielding for pedestrians during the night increased from 2% in the before condition to 5% and 8% for one month and six months after installation, respectively. Braking distance during the day increased from 87 feet in the before condition to 200 feet and 228 feet for one month and six months after installation, respectively (see Graph 2).

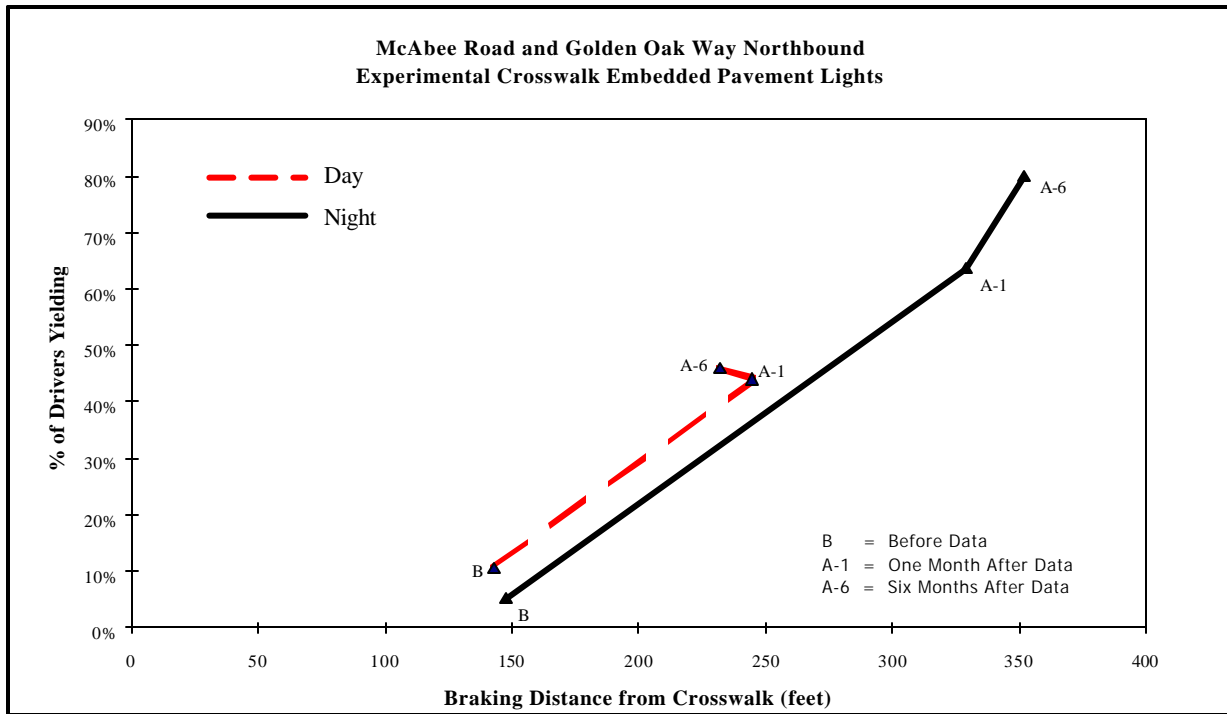
Graph 3: McAbee Road and Golden Oak Way northbound

- Drivers yielding for pedestrians during the day increased from 10% in the before condition to 44% and 46% for one month and six months after installation, respectively. Braking distance during the day increased from 143 feet in the before condition to 245 feet and 232 feet for one month and six months after installation, respectively.
- Drivers yielding for pedestrians during the night increased from 5% in the before condition to 64% and 80% for one month and six months after installation, respectively. Braking distance during the night increased from 148 feet in the before condition to 329 feet and 352 feet for one month and six months after installation, respectively (see Graph 3).
